Manhole Inspection Summary

Manhole # S35W__040MH

Insp Date: **3/7/08 11:37 AM**

Location Address: **53 e heath**

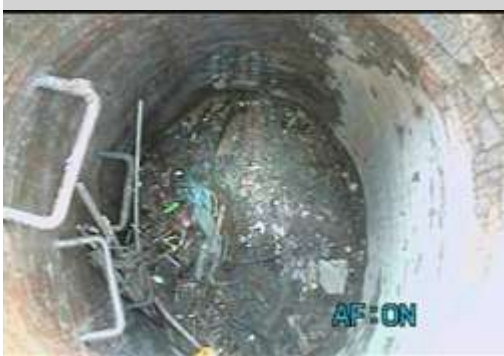
Defect 1

Count: **4** Missing: **0** ☒ **Corroded**

corroded steps

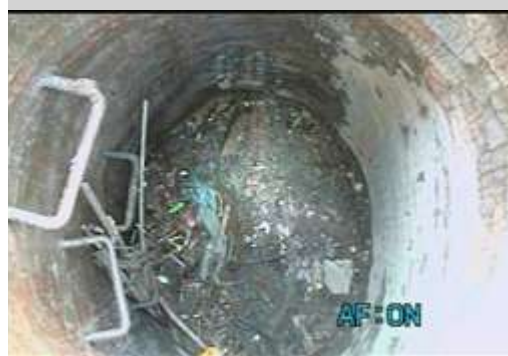
Defect 2

Condition: ☐ Sound ☐ Cracked ☐ Root Intrusion ☐ Deteriorated ☐ Leaks ☒ **Debris**

Channel Debris

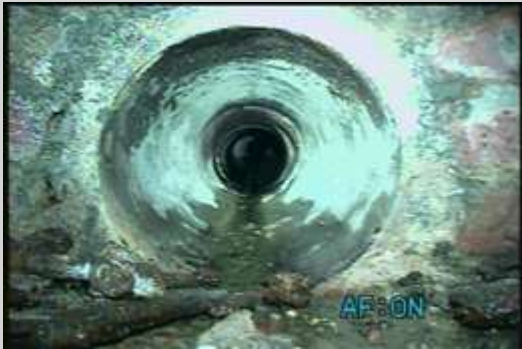
12 O'Clock Outflow

8 in. Circular Gravity Sewer
Pipe Out @ 12 O'Clock

Pipe Material: **Clay** ☐ Pipe Lined

Invert Depth: **7.70** (ft.) Flow Characteristics: **None**

Deposits: ☒ None ☐ Mud ☐ Sludge ☐ Debris ☐ Grease

Infiltration: **None** Pipe Seal Cond: **Unknown**
